Xbox 360 Top Vent Replacement

Use this guide to remove the gray plastic top vent from your Xbox 360.

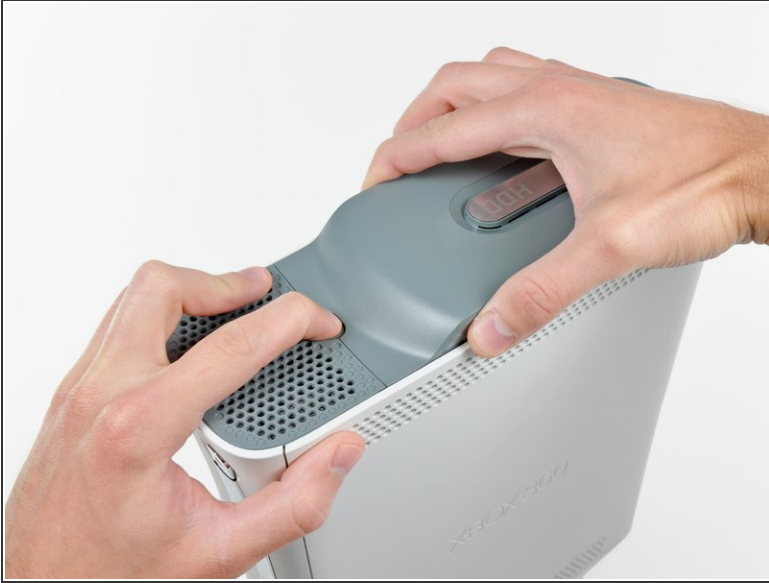
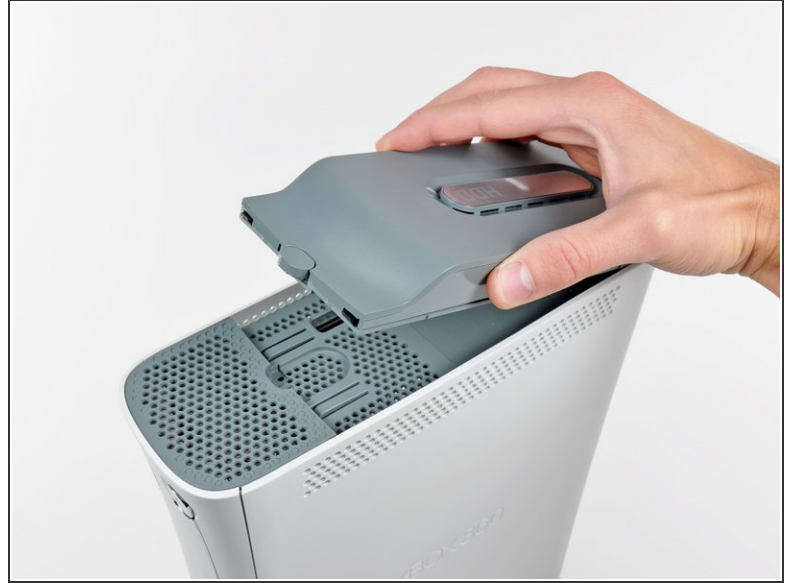
Step 1 — Xbox 360 Top Vent Replacement

- Grasp the hard drive assembly and press the release button while lifting its front edge.
- Remove the hard drive assembly from the top vent.

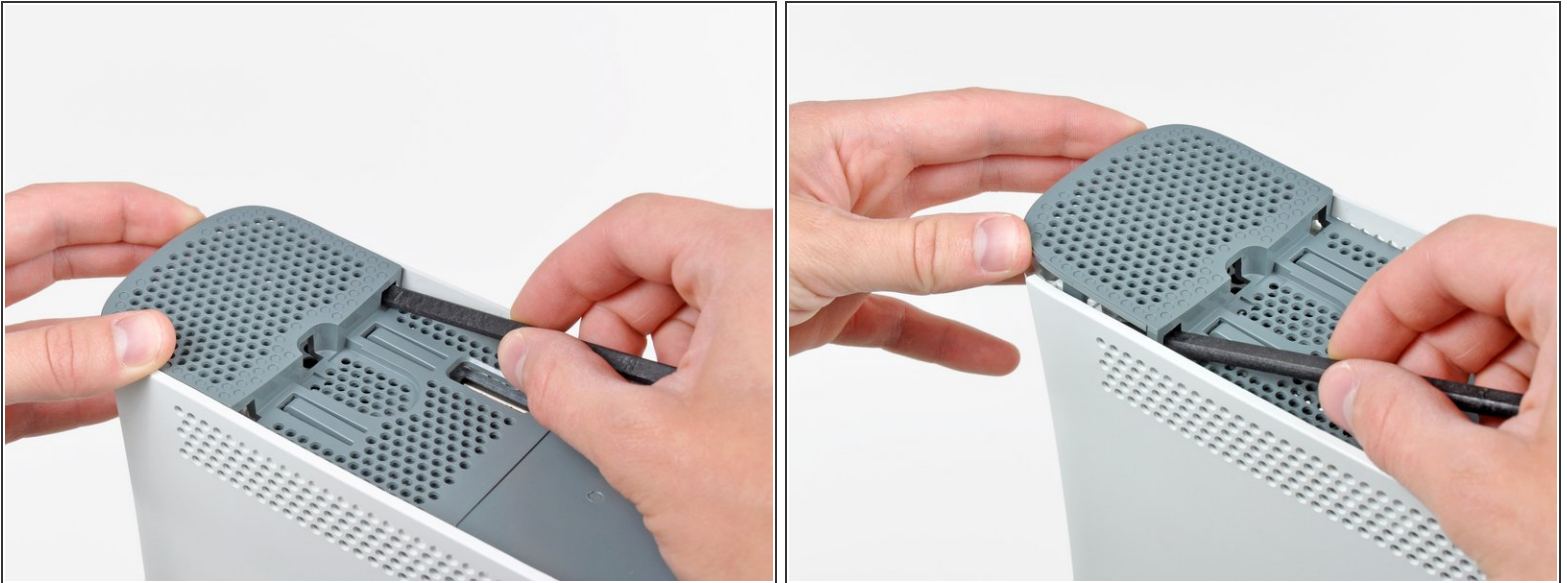
Step 3

- Insert the flat end of a spudger into the small gaps previously mentioned to release the clips.

i You may also use the long finger of an Xbox 360 opening tool to accomplish this task.

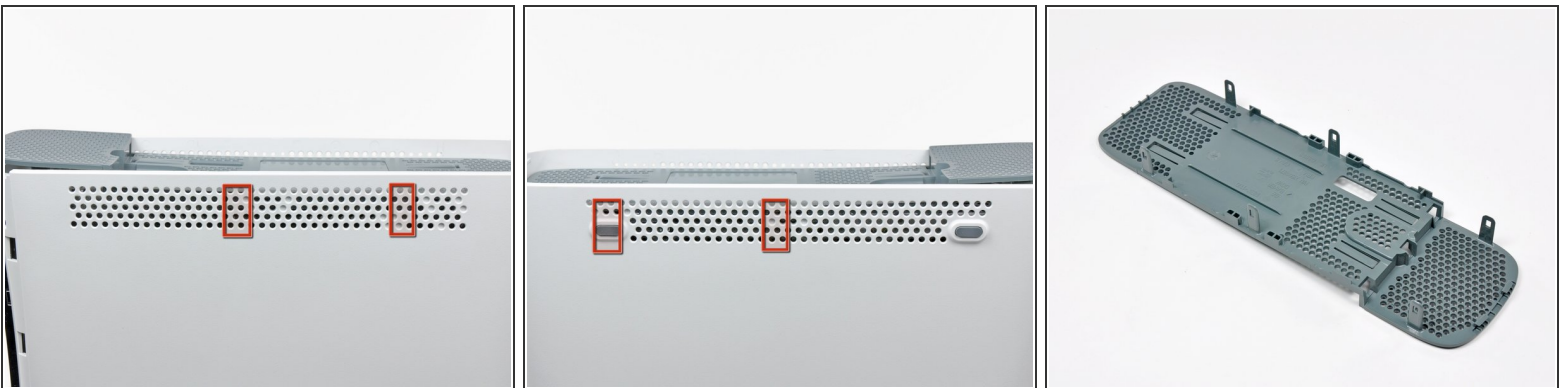
Step 4

i In the next few steps, you will use the tip of a spudger or the finger of an Xbox 360 opening tool to release the clips along the left and right sides of the top vent. Their locations are highlighted in red.

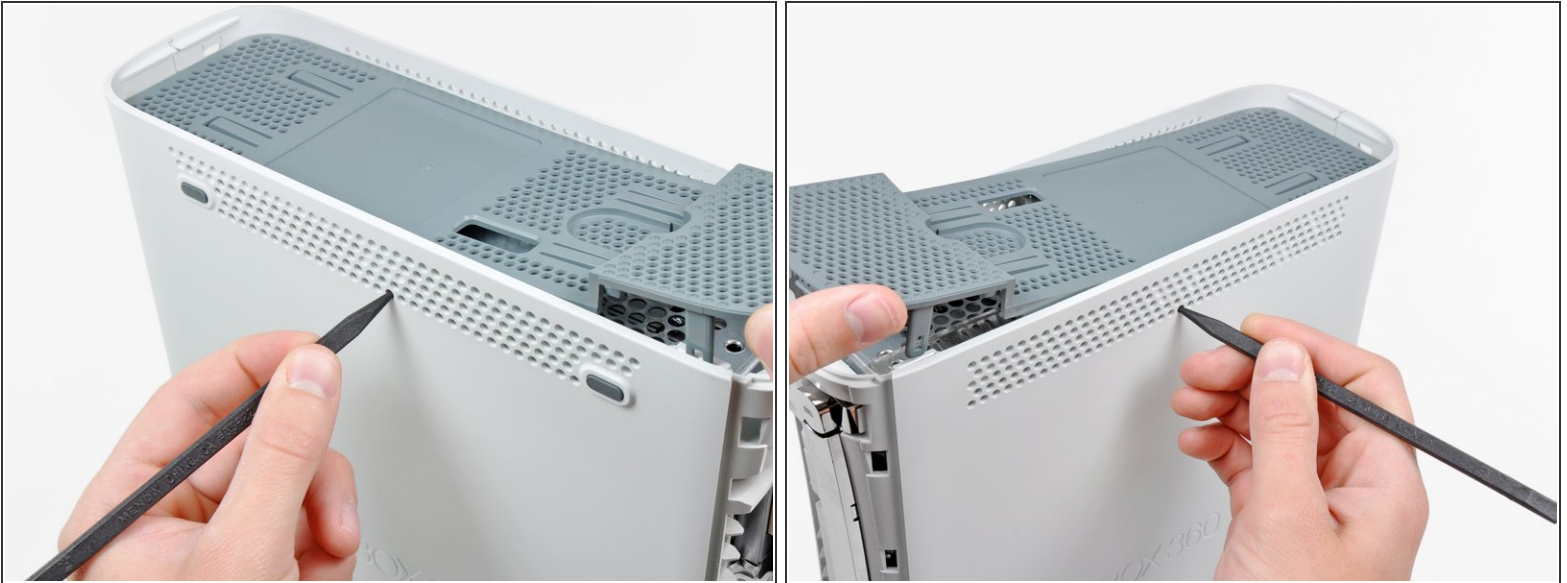
Step 5

- To release the clips, work from the middle of the top vent.
- While slightly lifting the front edge of the top vent, use the tip of a spudger to push the clips closest to the center of the top vent towards the inside of the console.

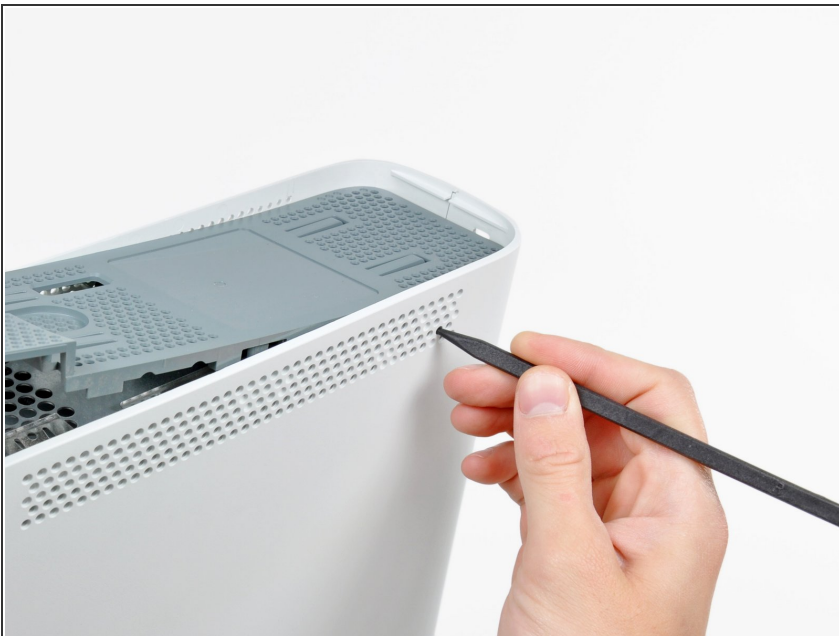
Step 6

- Use the tip of your spudger to release the clip on the top vent nearest the back of the Xbox's upper case.
